Sample Case : TOSHIBA Factory (Injection Molding Machine)

<p>Miracle Boy was installed to the injection molding machine at TOSHIBA.</p>

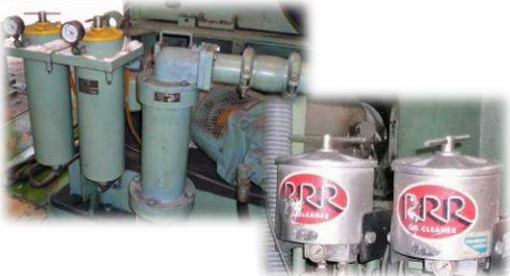
<p>Miracle Boy is installed (installation is simple & easy)</p>

Counter Measure	Installing MB to the hydraulic oil tank of the injection molding machine
-----------------	--

Result	<p>After installation, acid level stays 0.1~0.2mgKHO/g & no viscosity change measured.</p> <p>Conductivity is also maintained 1.0mg/100ml which is same level as brand-new oil.</p>
Voice of Customer	<p>Since the installation in 2007, hydraulic oil supplier has not even recommended us to change oil as it is well maintained clean.</p> <p><u>Compared to the past, we have reduced about 200,000 liter of oil in 10 years</u> using for 7 units of injection molding machines. (Total CO2 reduction since the installation is estimated 500t.)</p> <p><REDUCED ANNUAL COST OF EXCHANGING OIL></p> <p>1600t Injection Molding Machine 4,000L = US\$ 19,000/YEAR</p> <p>It's been no hydraulic related problems such as expensive electric valves and hydraulic pumps.</p>
