Sample Case : Gas Power Plant (Steam Turbine)

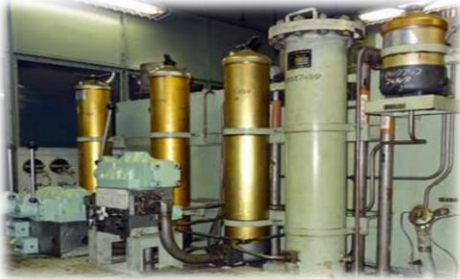
Electro-hydraulic governor for Gas Turbine (1,100MW) had oil oxidize issue which caused sudden malfunction.
