# Sample Case : TOSHIBA Factory (Injection Molding Machine)

<p>Miracle Boy was installed to the injection molding machine at TOSHIBA.</p>
---	---

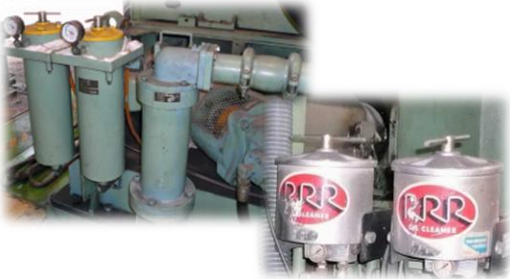
<p>Miracle Boy is installed (installation is simple &amp; easy)</p>
---	---

<p>Counter Measure</p>	<p>Installing MB to the hydraulic oil tank of the injection molding machine</p>
------------------------	---

<p>Result</p>	<p>After installation, acid level stays 0.1~0.2mgKHO/g &amp; no viscosity change measured.          Conductivity is also maintained 1.0mg/100ml which is same level as brand-new oil.</p>
---------------	---
